10 Gun Battery Seawall Repairs

Client: Solent Coastal Partnership Scheme

Project Detail

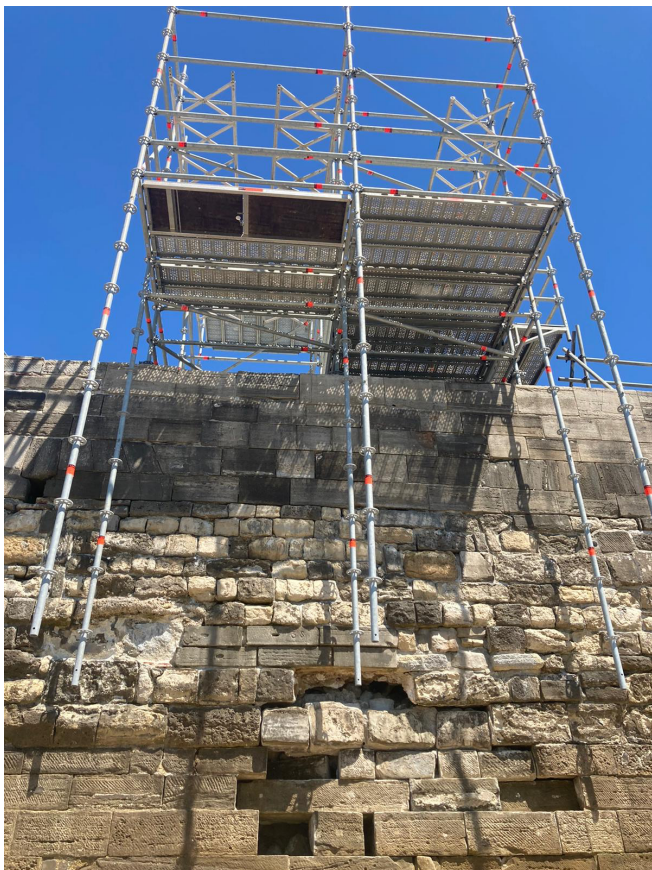
One of the areas that required urgent repairs is 10 Gun Battery, where blockwork had been displaced damaging the integrity of the seawall.

Figure 1: Clearly showing the damage to the sea wall and the Layher system scaffolding

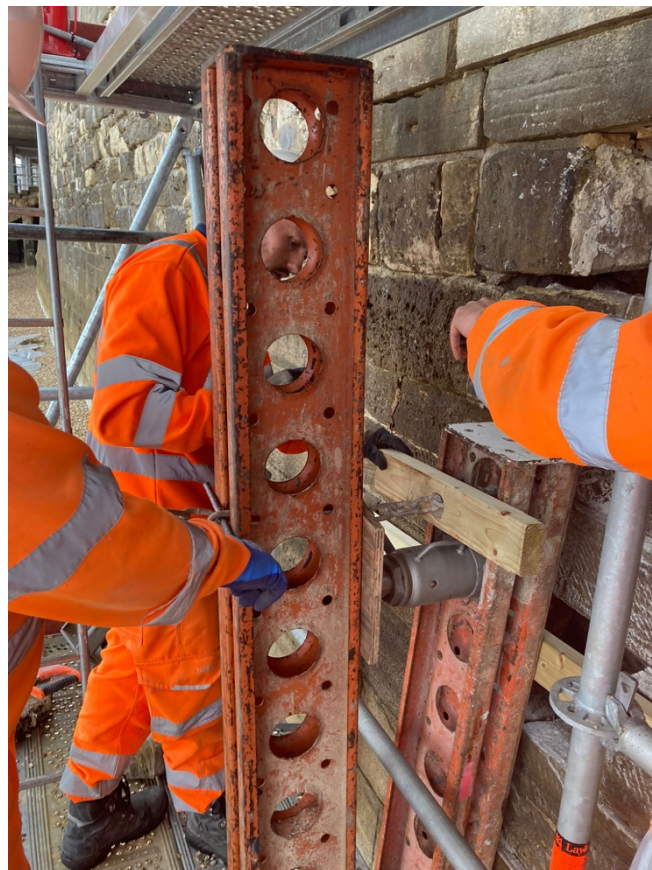
Figure 2: The original blocks that had been retrieved from the foreshore being reset in their original position

- Resetting displaced blockwork to its original position and repointing with a natural cement
- Retrieving displaced blockwork from the foreshore and resetting in original position, securing with dowels, and repointing with a natural cement
- Injecting grout in the voids directly behind the blockwork.

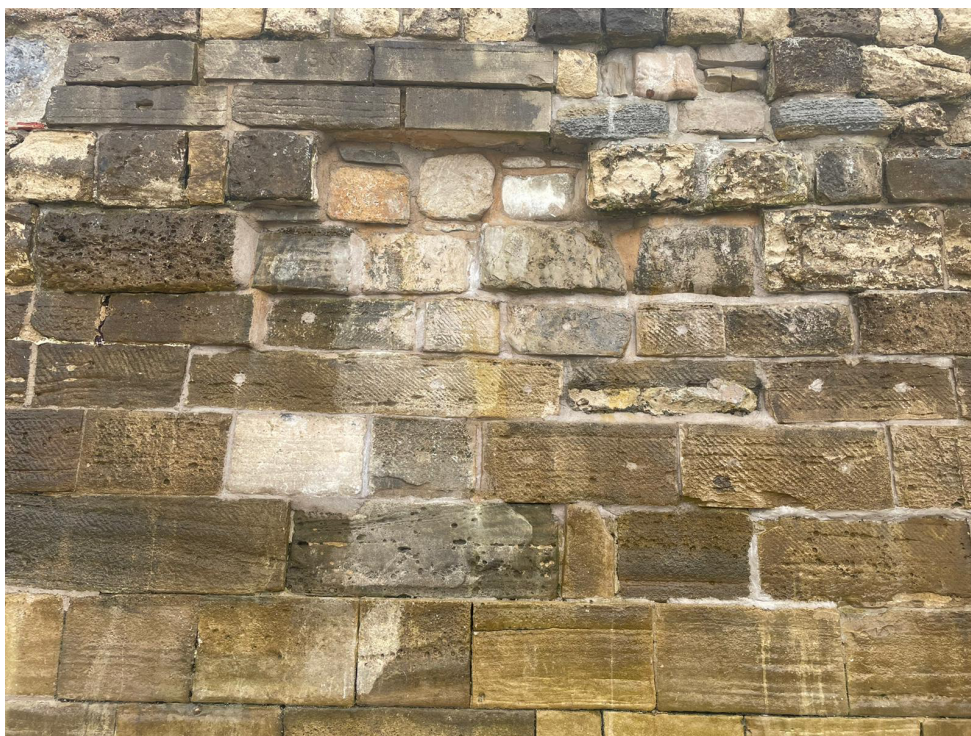
Figure 3: The repaired wall
