ALFORD BRIDGE REFURBISHMENT

Client: Somerset County Council Rights of Way

Project Detail

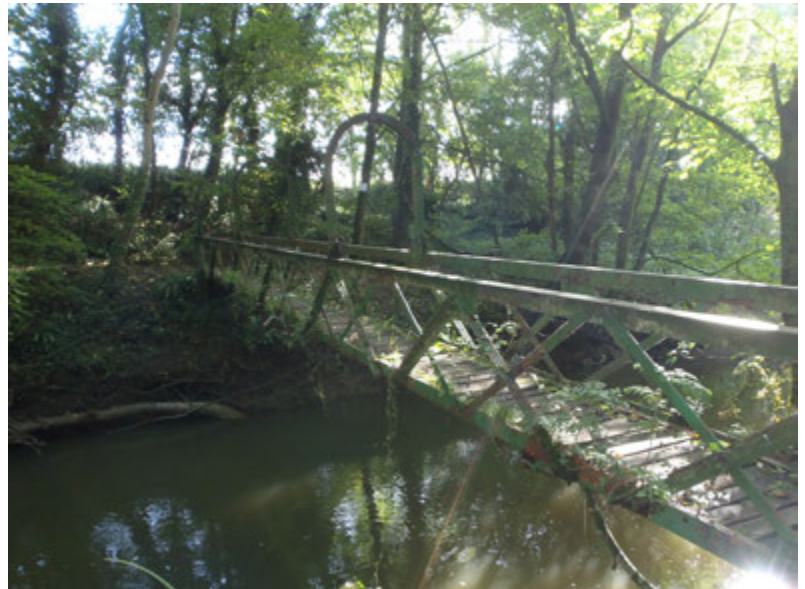
Access to the site, which was through private land and local authority owned woodland, was very restricted. By adapting a mini piling rig to suit the surroundings, we were able to move small plant to the location without impacting on the area.

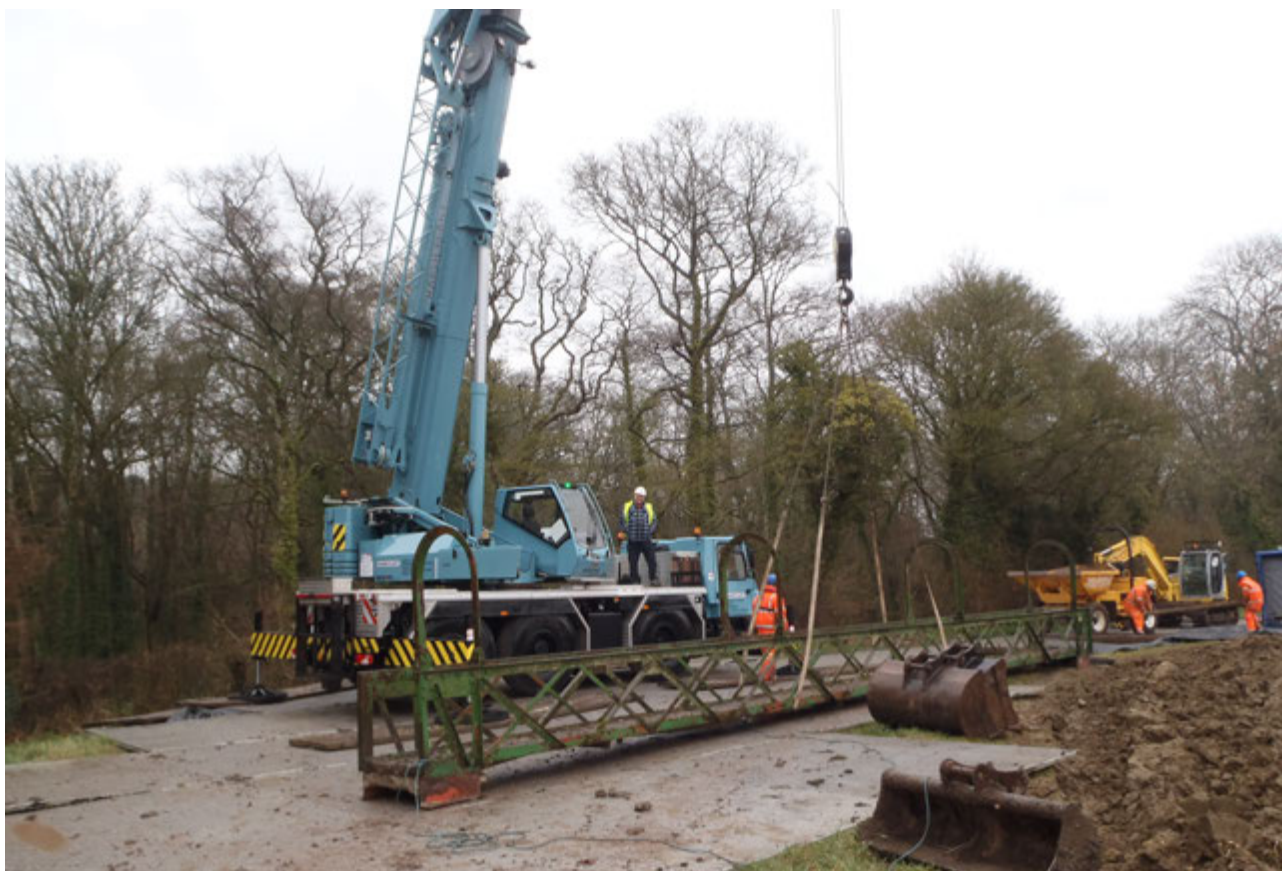
Following the completion of the temporary bridge, the existing bridge was removed from its abutments, lifted and placed alongside the crane pad. The bridge deck was then broken down into components on site and refurbished.

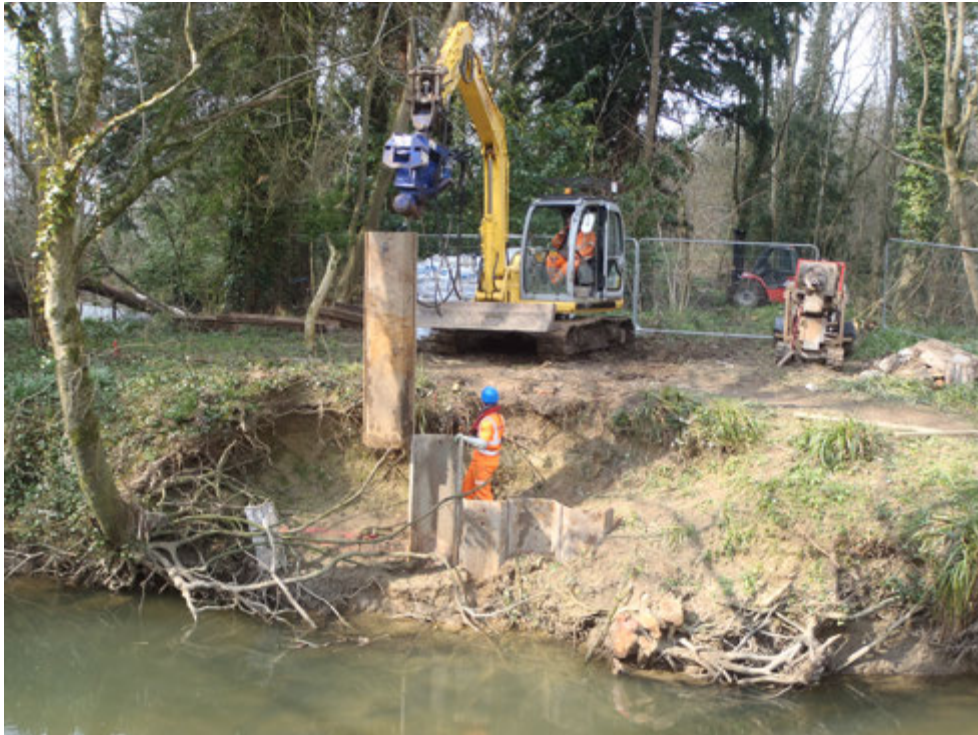
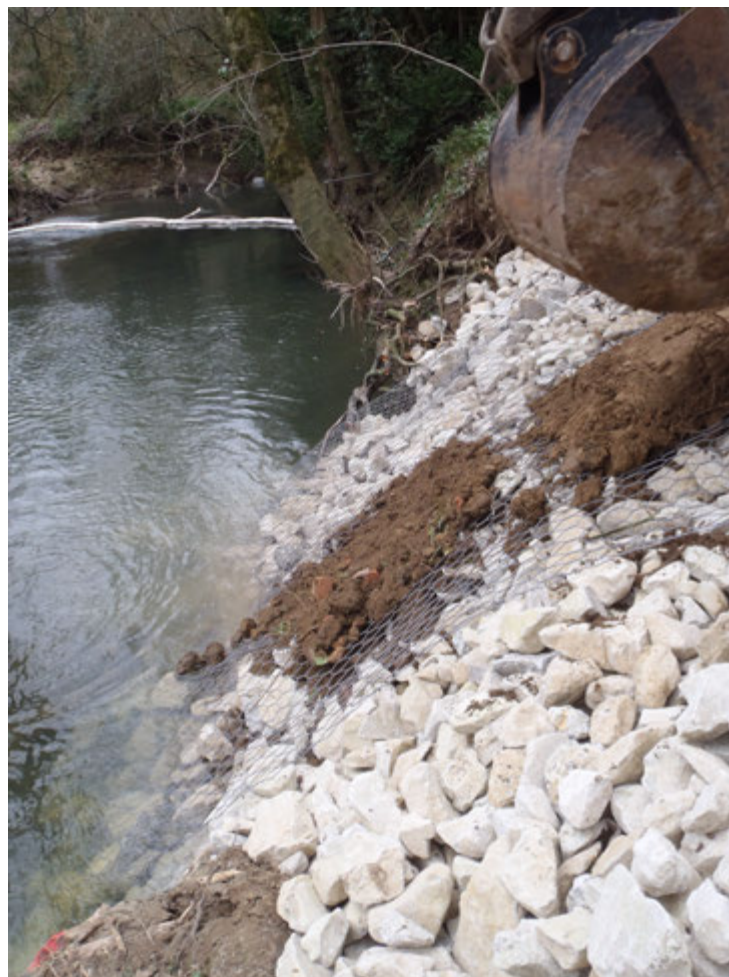
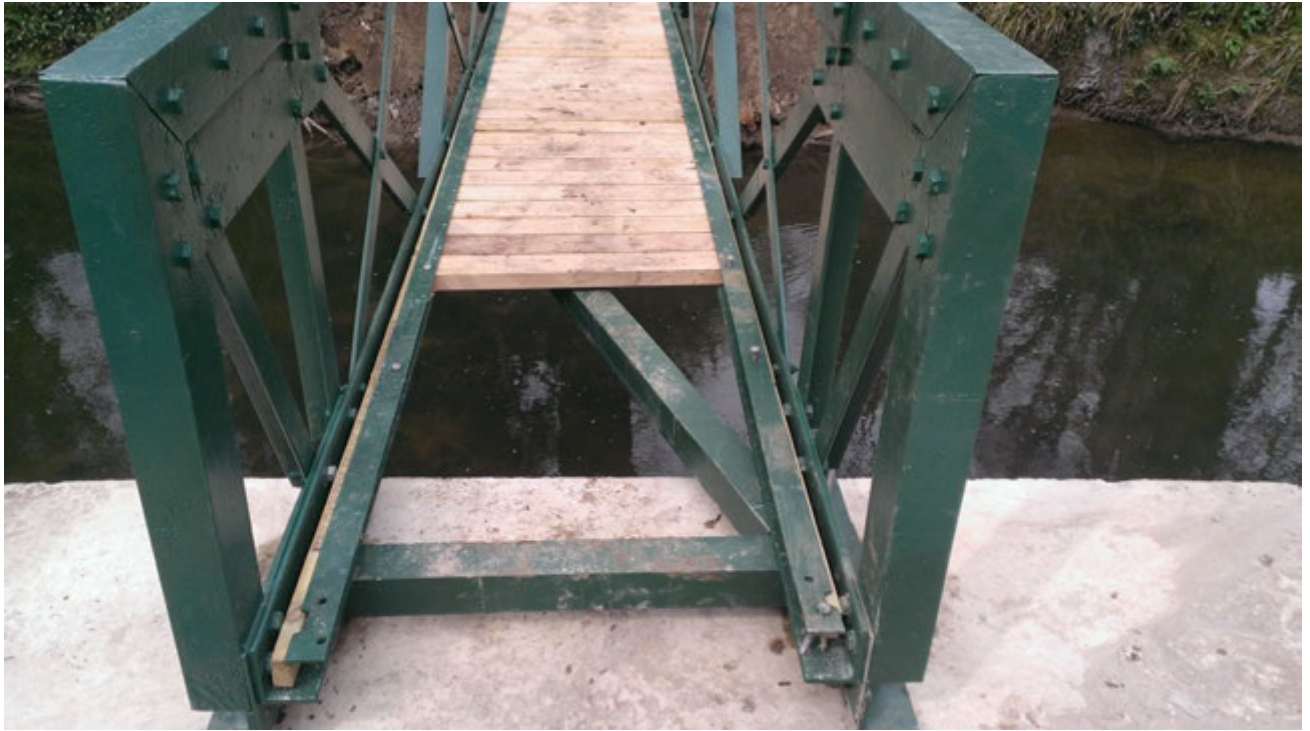
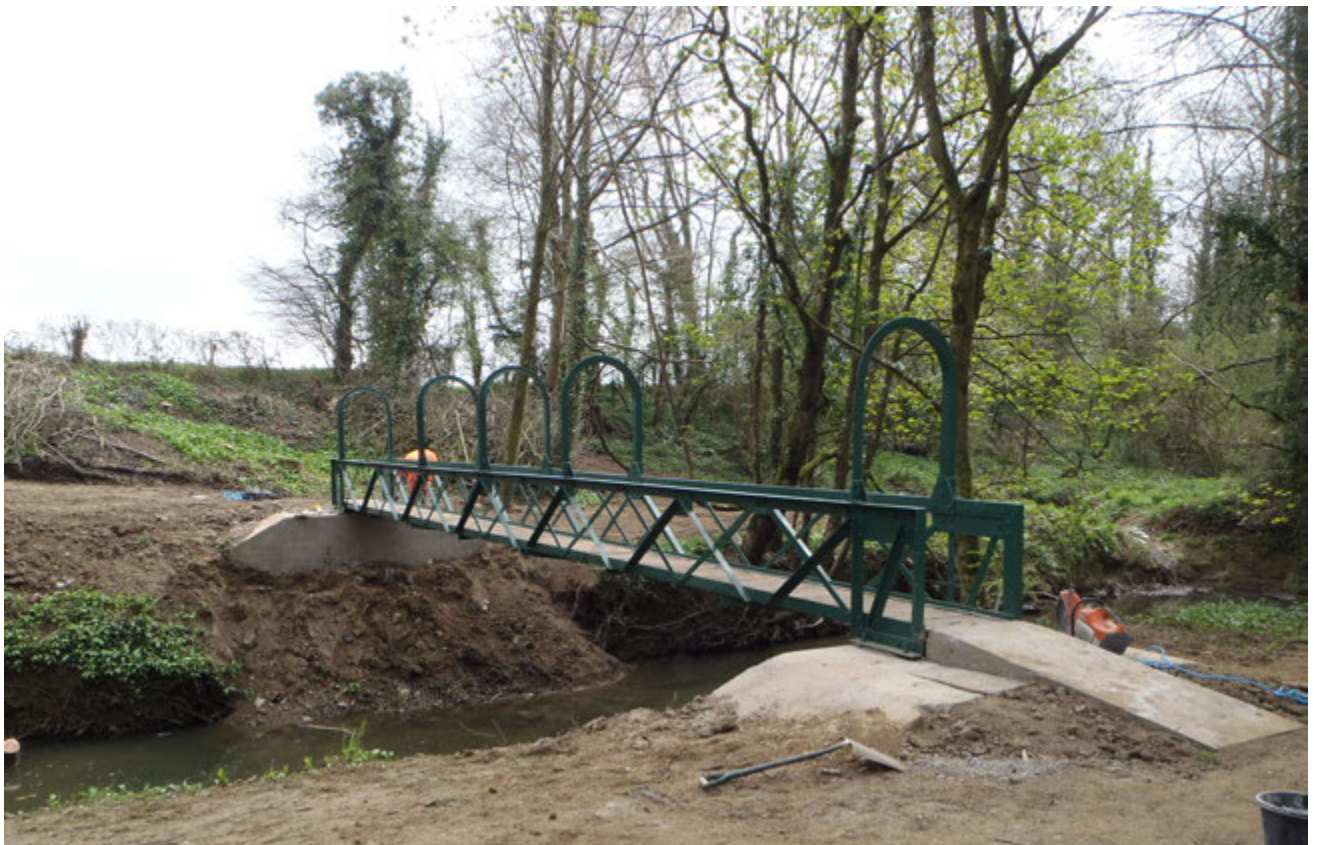
Short interlocking steel sheet piles were driven into the toe of the riverbank along the scoured section. This was then benched to accommodate the rock armour infill. This was transported to the northern bank using a 4-tonne dumper and placed with care using the digger bucket. Rock armour was overlain with geotextile and soil.
