ROCKLEY VIADUCT IV

Client: Dyer & Butler

Project Detail

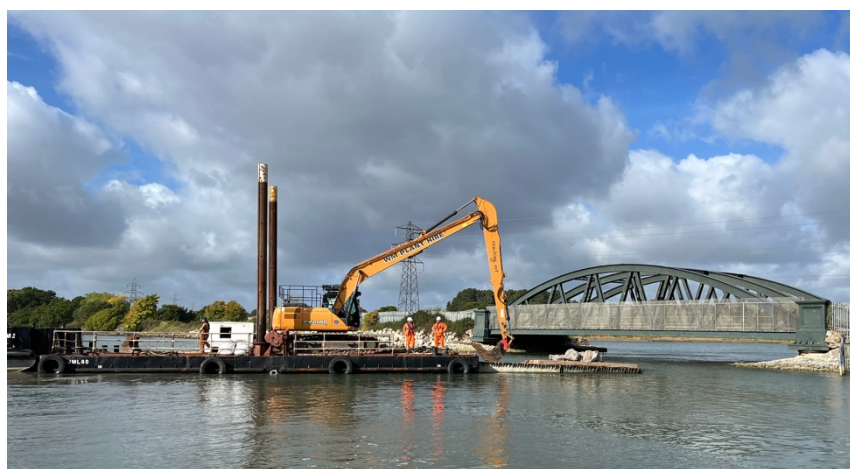
Figure 1: One of the excavators on the barge approaching the viaduct

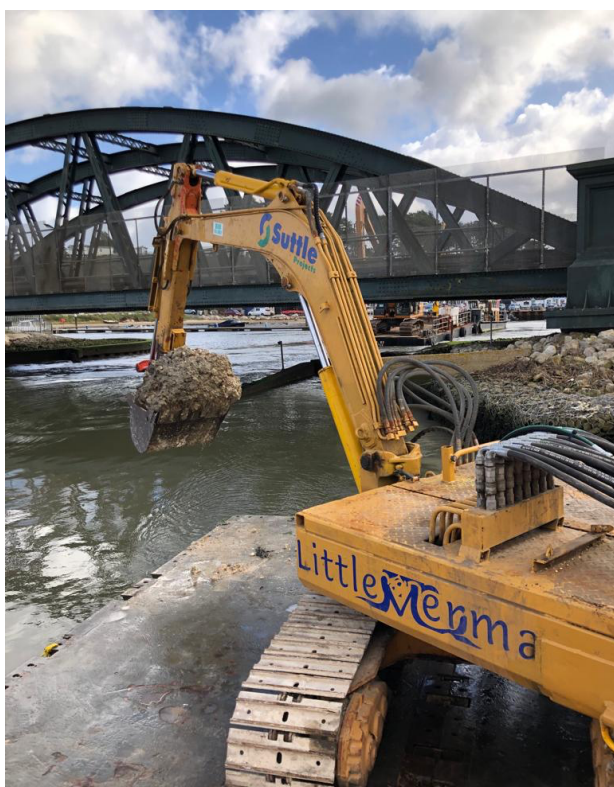
Figure 3: The Little Mermaid on the other side of the bridge to work having gone underneath.

It provides the perfect opportunity to use 'The Little Mermaid', a remote-controlled excavator created by ourselves and ideal for use in difficult to reach areas like this one. Due to the small size of the Little Mermaid it can also work with the tide to go under the bridge so that we can work from the other side, something that would never be possible with a full size excavator that requires an operator.

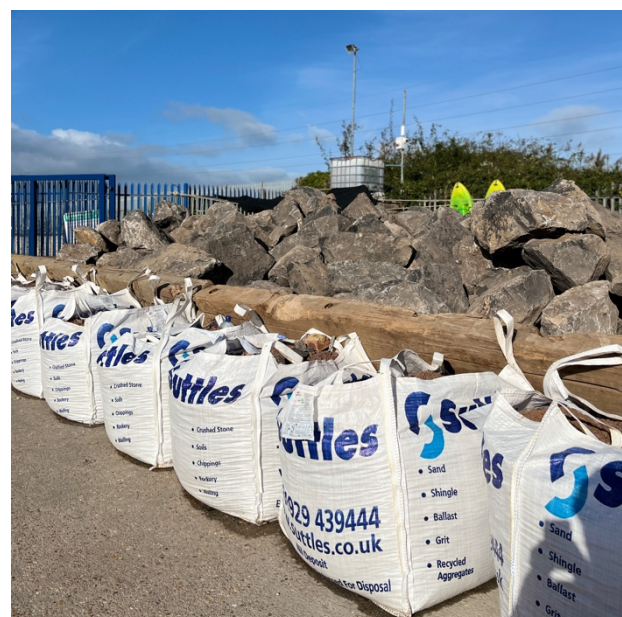
Figure 4: The stone, having been delivered by our sister company; Suttle Stone Quarries

Works at Rockley Viaduct are part on an ongoing project that started back in 2020. This phase of the project aims to implement a permanent design solution that will provide medium-term stability to the structure by replacing the existing damaged scour protection system and washed-out apron with a rock armour system to protect bridge columns and their underlying caissons.
