## **Swanage Stone Quay Repairs**

**Client:** Swanage Town Council

### **Project Detail**

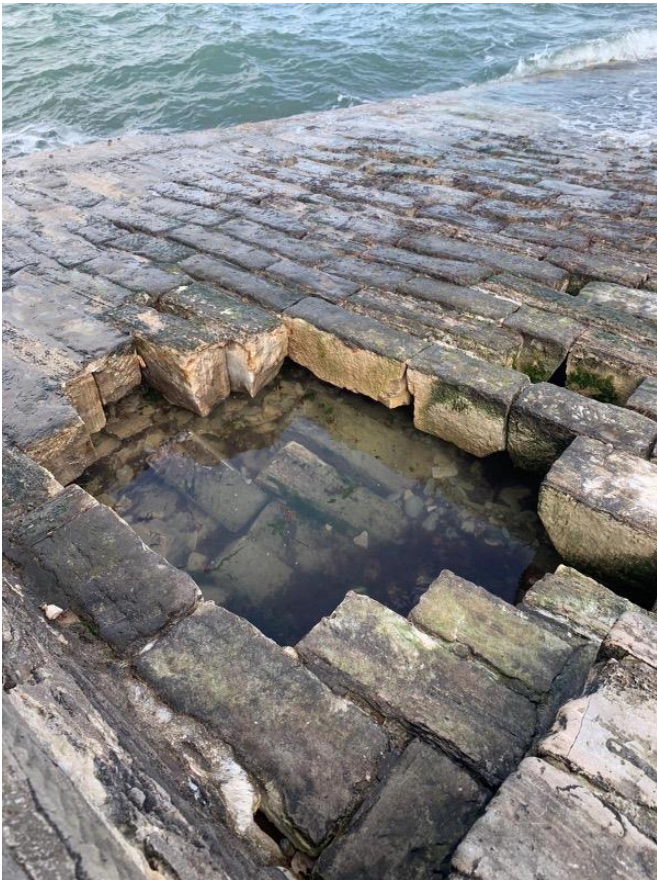
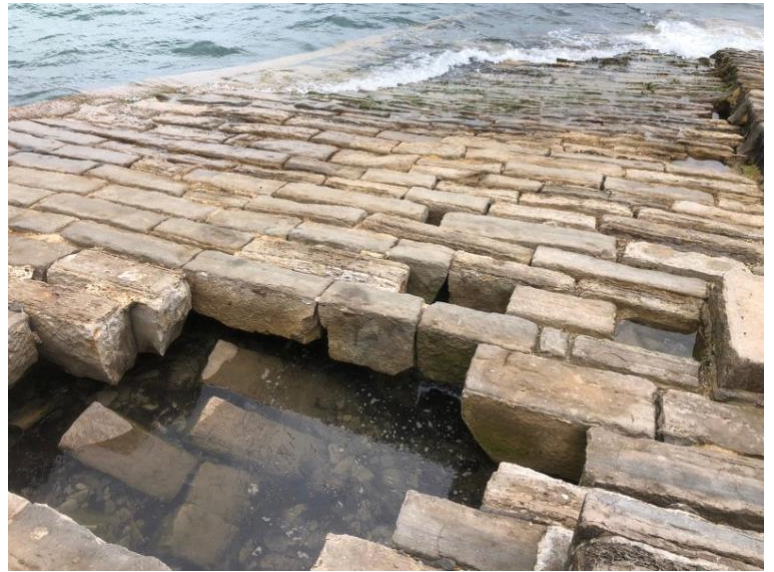
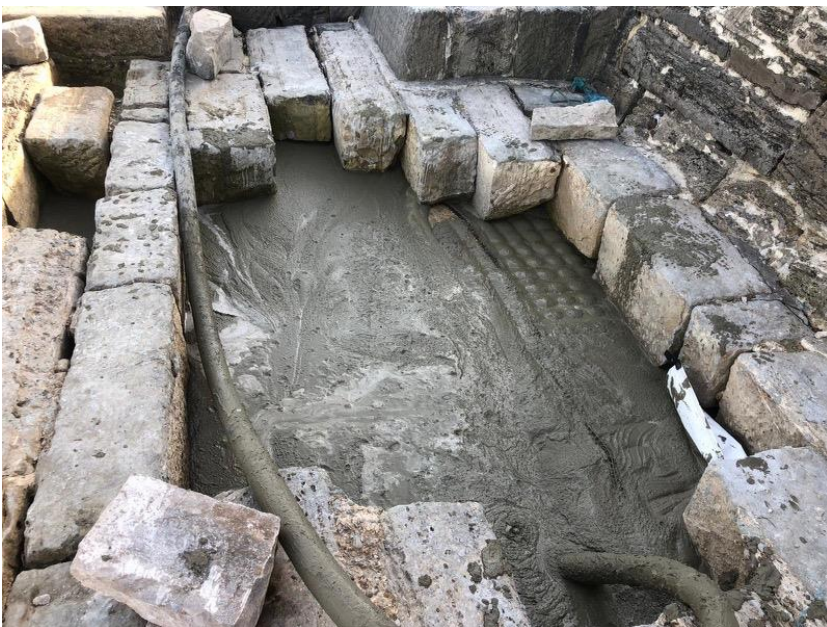
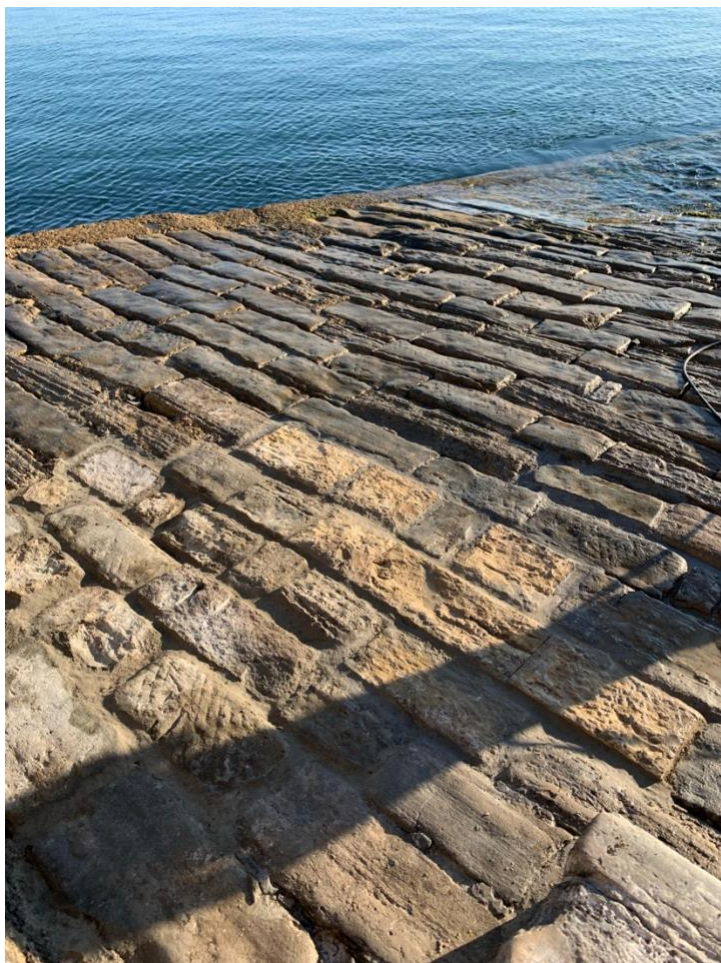
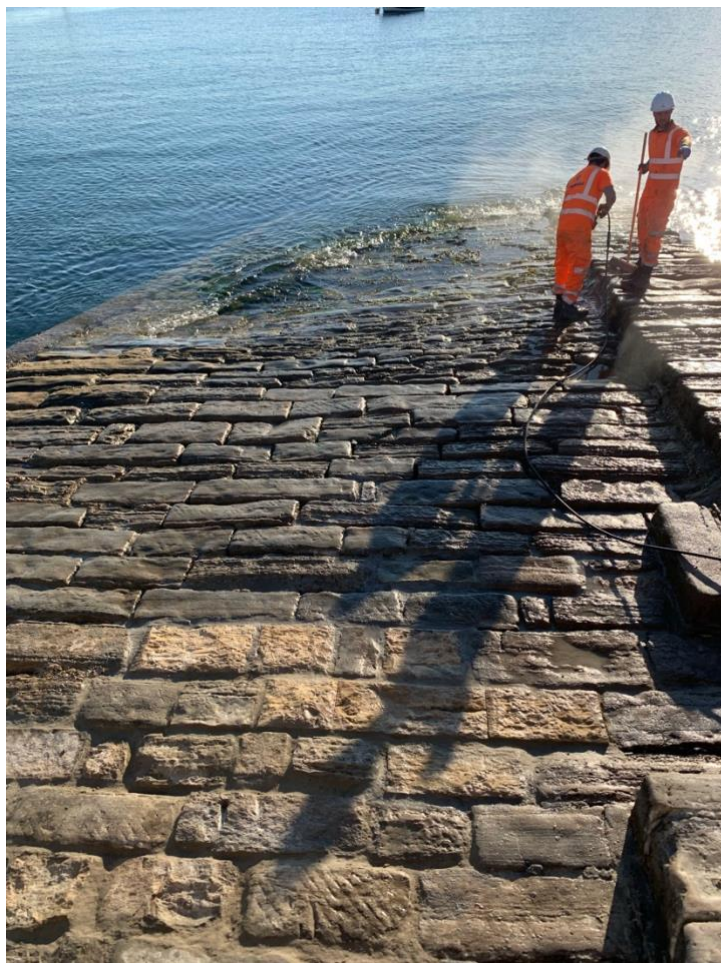
Through ingress from wave action, over a long period of time, this rubble had gradually been washed out to leave a void filled with water on high tides. Initially bridging the void entirely, an area of the stone encasement eventually collapsed into the void below, leaving the area very unsafe during a very busy holiday season in the town as the quay itself is a very popular location in the summer for crabbing and children playing and it was something that the locals were very keen to see fixed because of the danger it posed.

Initial thinking was to look for gaps in the leading edge to be filled, to allow for concrete to be poured in the void behind. We rejected this philosophy as the leading-edge area was particularly tidal, and with poor quality construction in this area we brought in the risk of concrete grout leaking on to the beach, creating pollution and leaving an uncertain quality of repair in the void. Instead we used pumped sea water to clean the beach sand out that was partially filling the void. Filling with water on a low tide washed this material out through the gaps creating the initial problem. We then brought some specialist knowledge to the table in terms of our use of grout filled mattresses and bag work that we frequently use on scour protection schemes associated with rail structures. We thus deployed and filled two large grout mattress bags within the void. These were filled with pumpable P40 micro concrete and pushed out into the recesses of the void, under hydrostatic pressure, as the filling continued.

Having filled the bulk of the void, sealing all external openings in the process, we could then top off with in-situ concrete. The recovered stones were too heavy to lay, in a difficult to access area for construction lifting plant. We cut stones down to form lighter "slippers", that could then be safely laid by hand. We supplemented the stones with some new material sourced from our own Purbeck stone quarry in Swanage. The final solution proved very in keeping with the original construction, and the client was pleased with a safe and efficiently delivered project.
