WRECCLESHAM SLIP

Client: Osborne

Project Detail

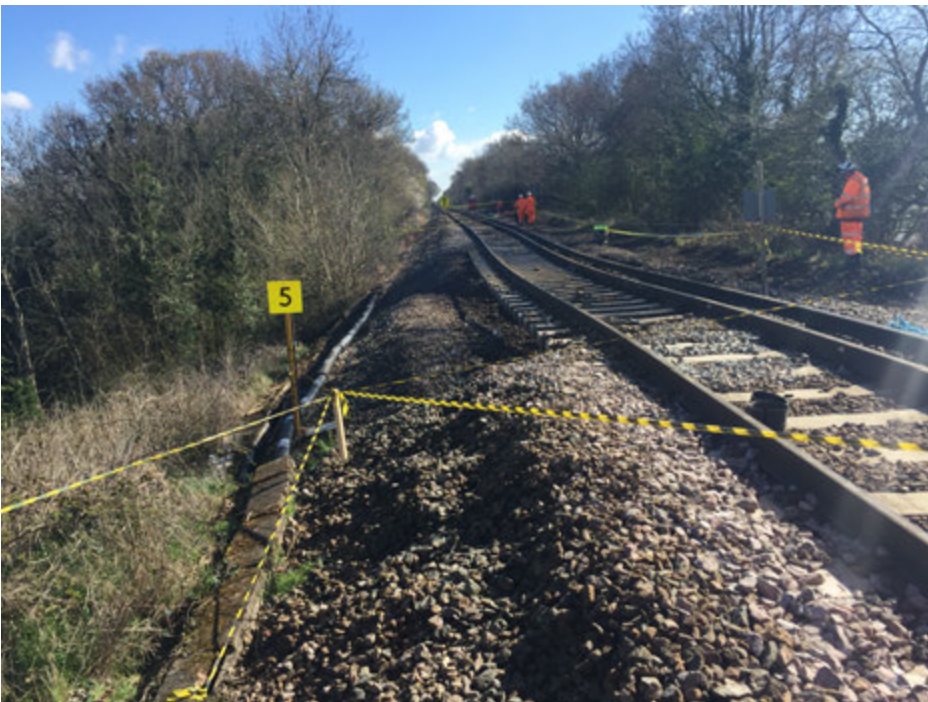
Figure 1: Emergency landslip

Accessing the railway from track level Suttle Projects undertook the emergency work by utilising Movax piling equipment to drive sheet piles in cantilever to stabilise the railway line.

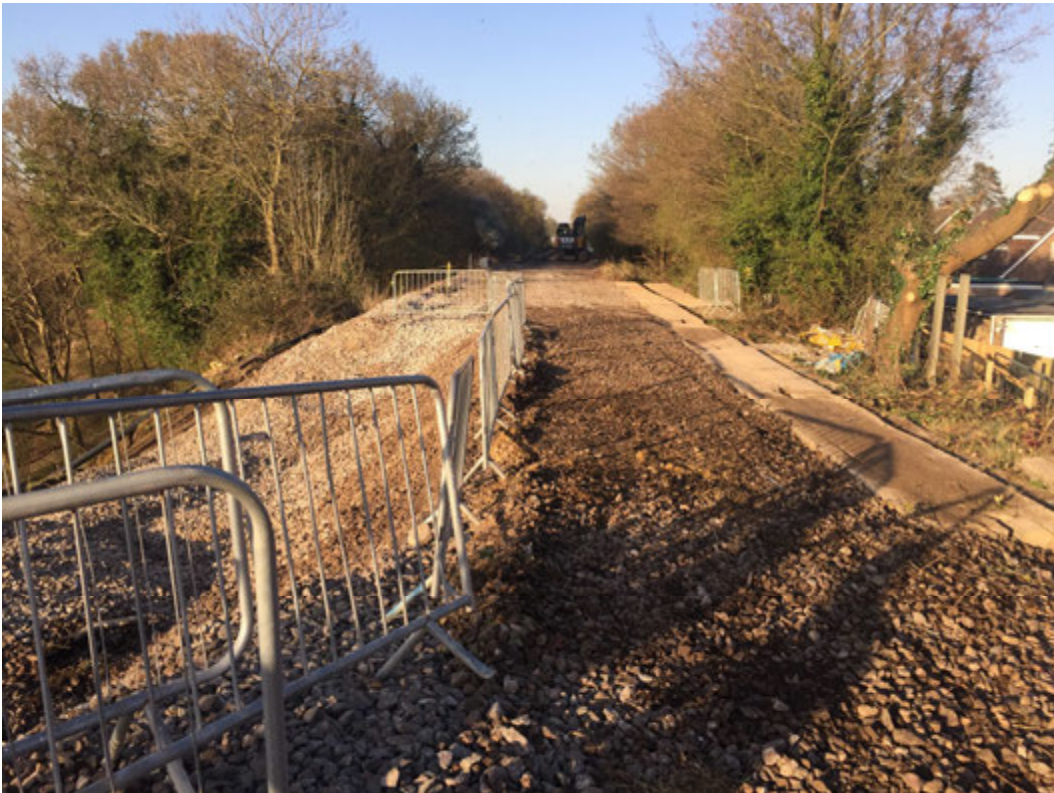
Figure 2: Piling platform at track level

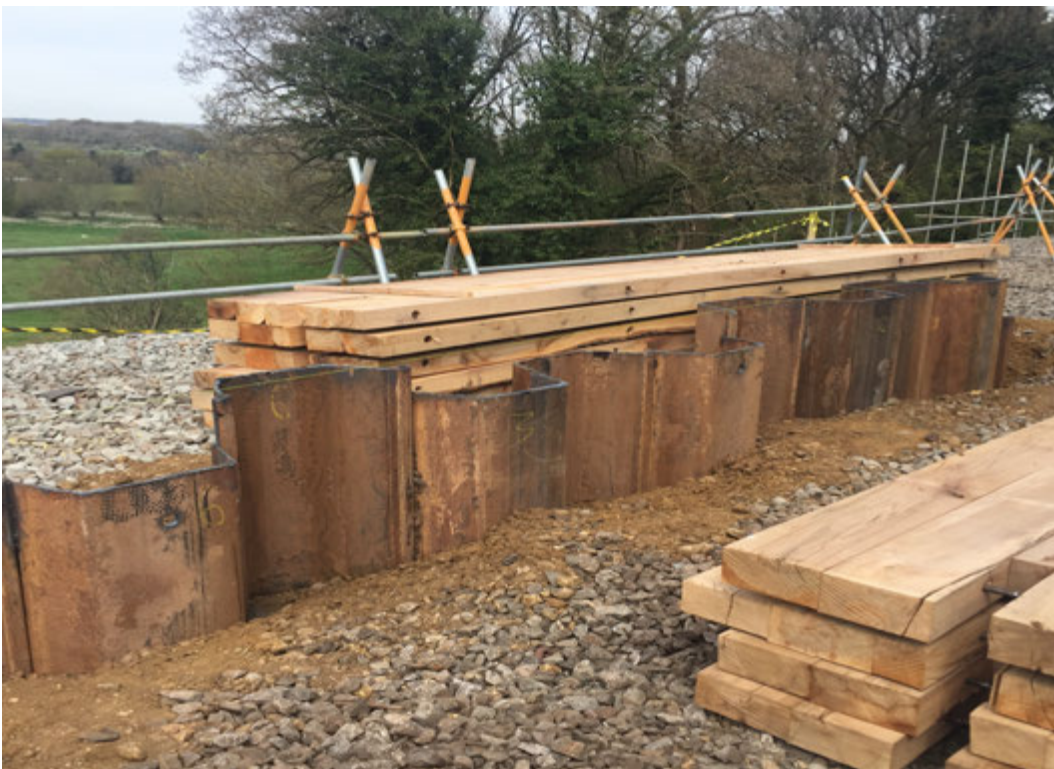
Figure 3: Sheet piles installed in emergency line closure

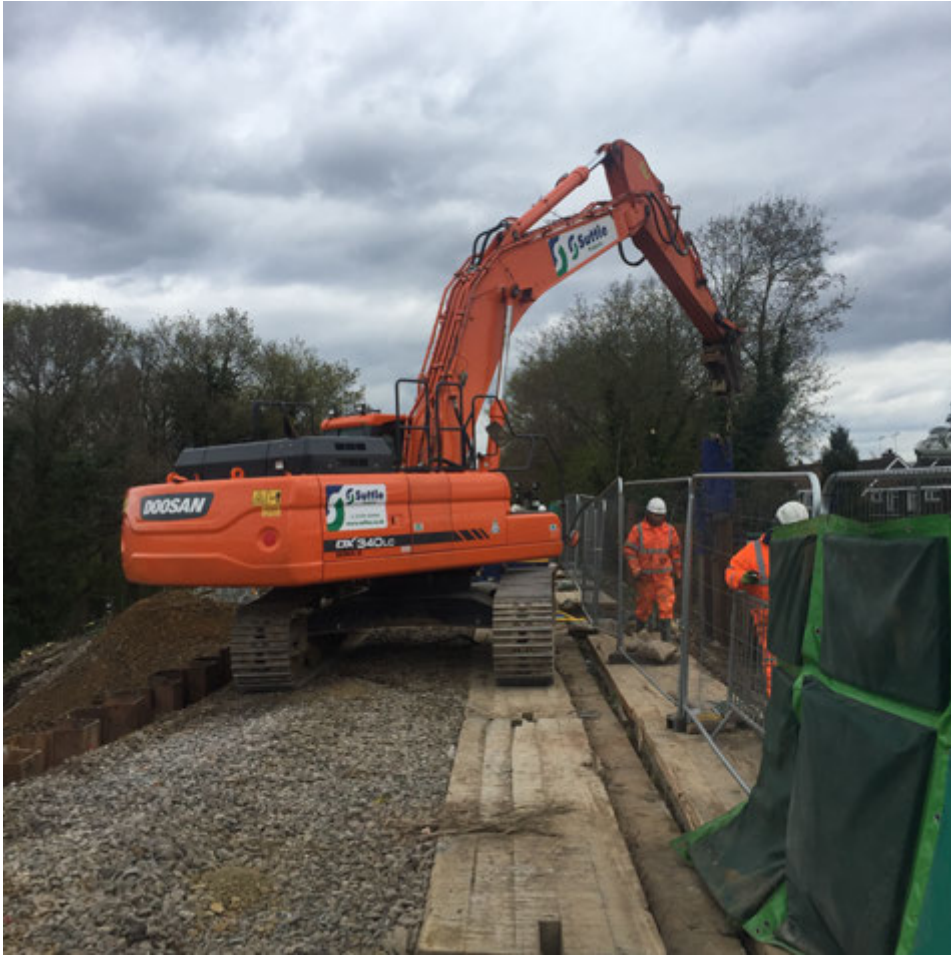
Figure 4: Impact driving at track level

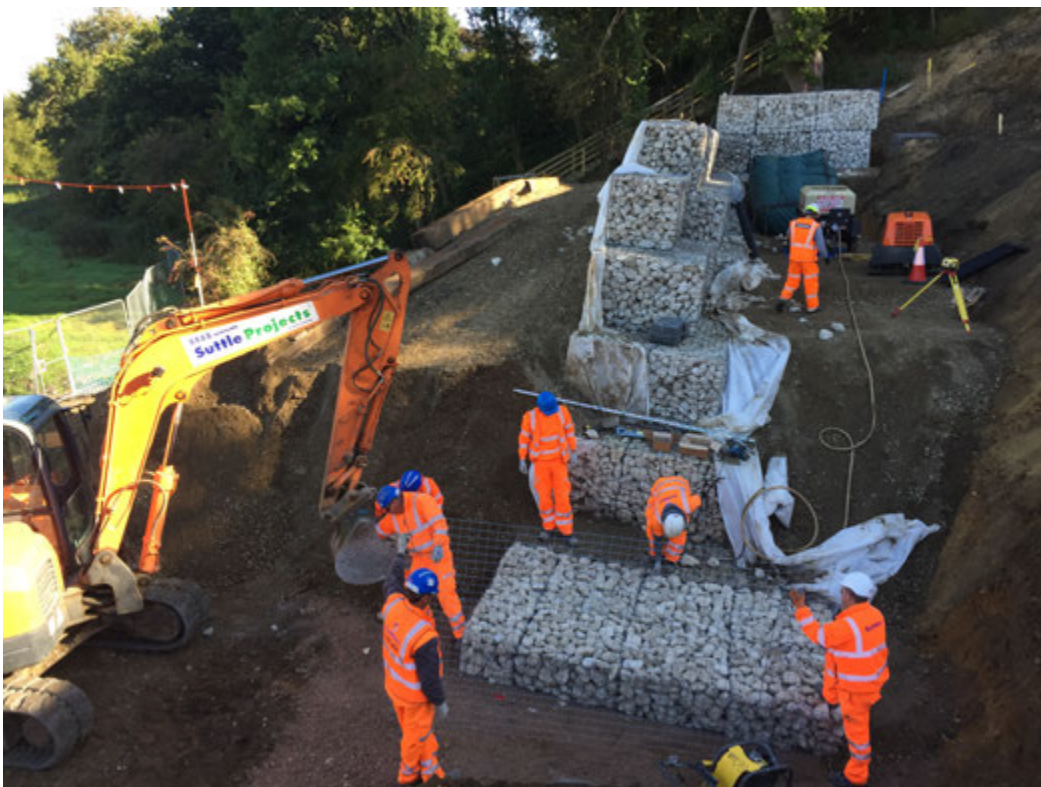
Figure 5: Gabion installation for permanent remediation

We made a longer-term access and compound from the fields below using recycled aggregates, and bog mats, for heavy plant to cross. Gaining access also involved installing a temporary bridge. This better access allowed for a more complete repair to be made to the embankment. This involved lots of gabions, longer sheet piles, and extensive ground re-profiling.

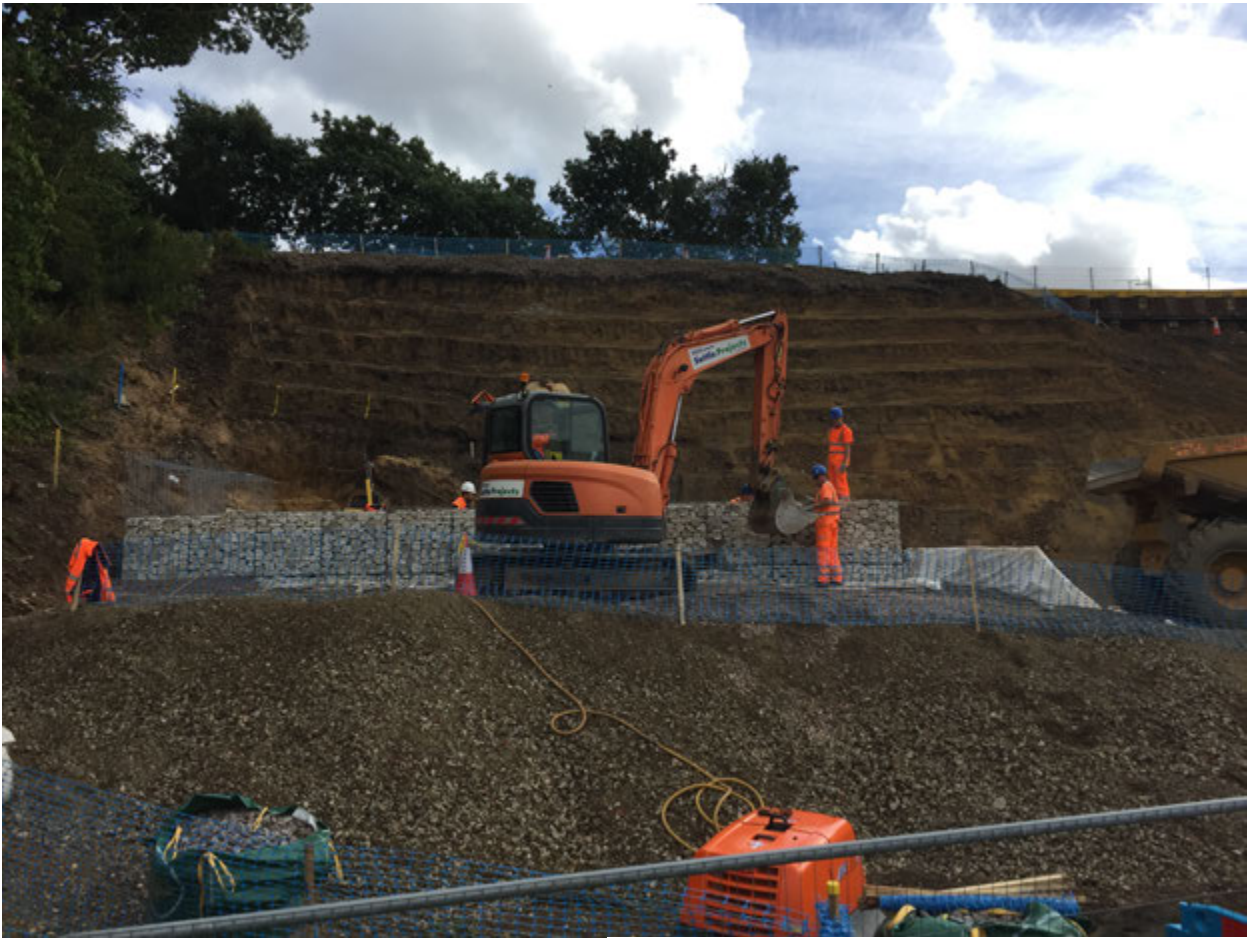
Figure 6: Extensive benching and gabion construction

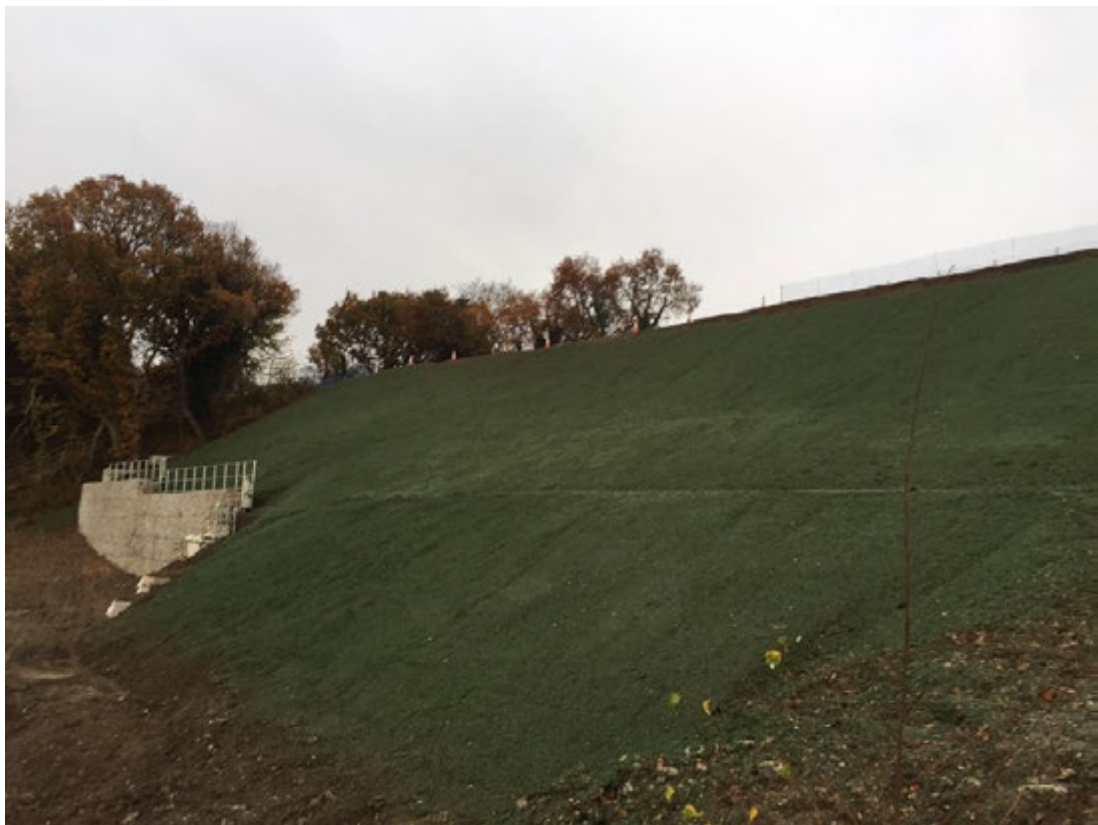
Figure 7:
Hydroseeding
of near
completed
embankment
repair
