Furzey Island Breakwater Repairs

Client: Perenco

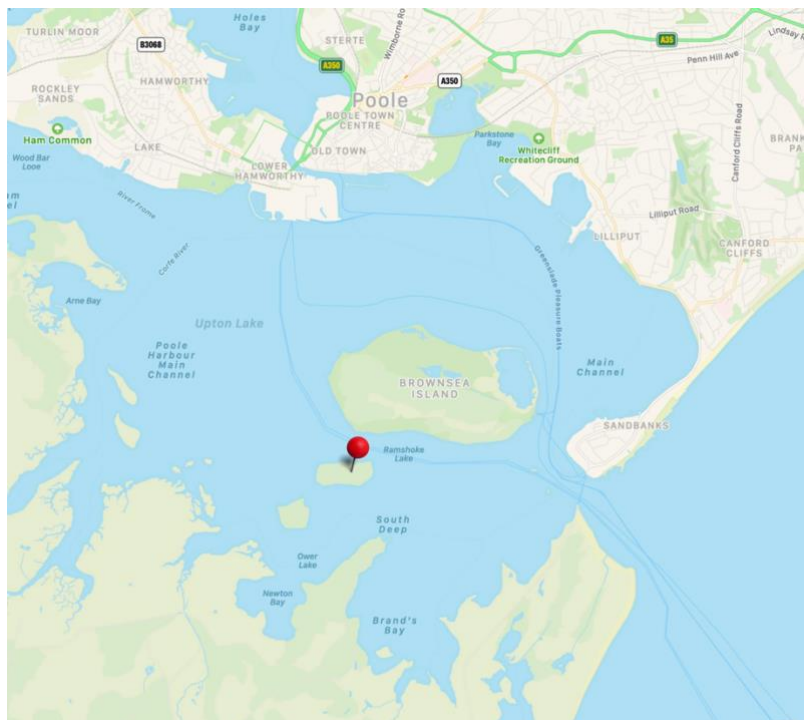
Furzey Island sits within the internationally recognised environment of Poole Harbour, it is a small island rich with wildlife including red squirrels and golden pheasants (marked on the map below with the red pin). It represents a challenge in terms of accommodating crude oil extraction facilities within an important Site of Special Scientific Interest. The operator, Perenco, thus place great importance on their contractors performing to the very highest standards of environmental compliance. All of the work was carried out with a Marine Management Organisation license.

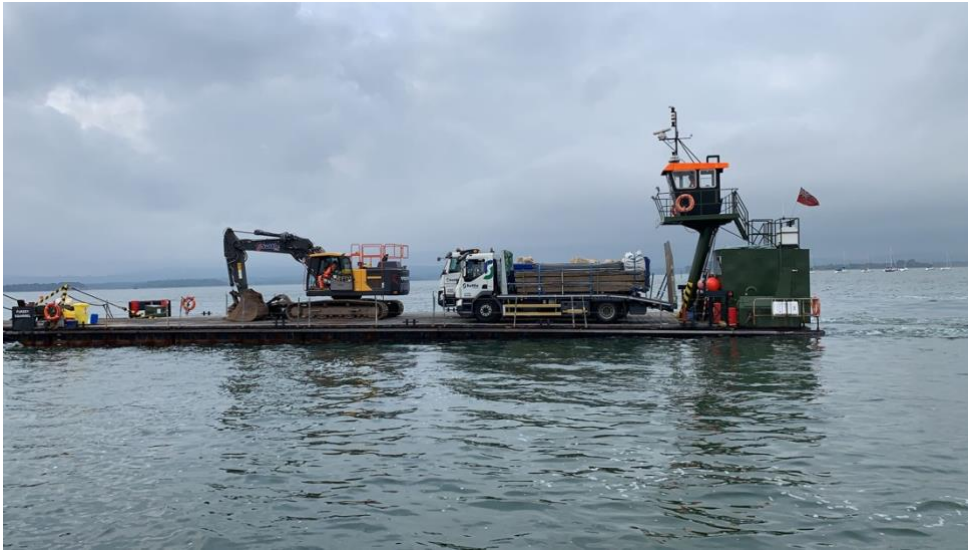
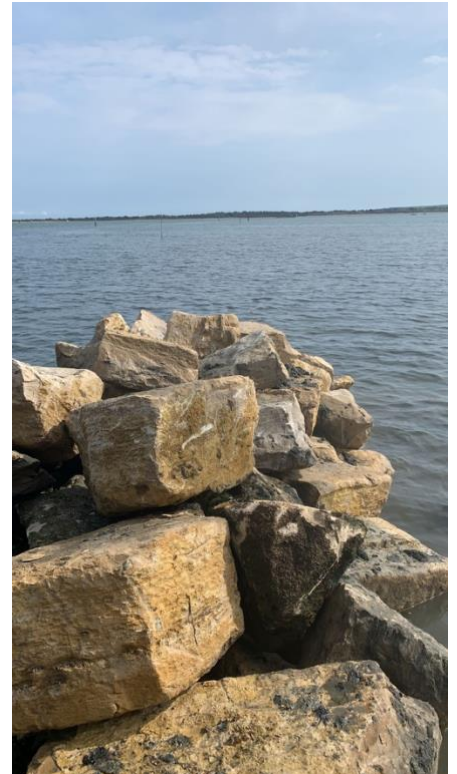
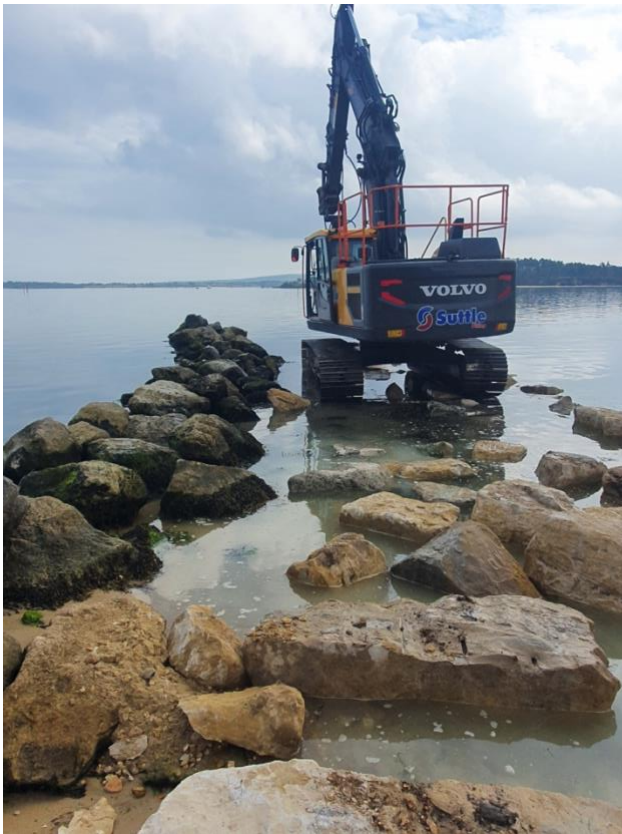
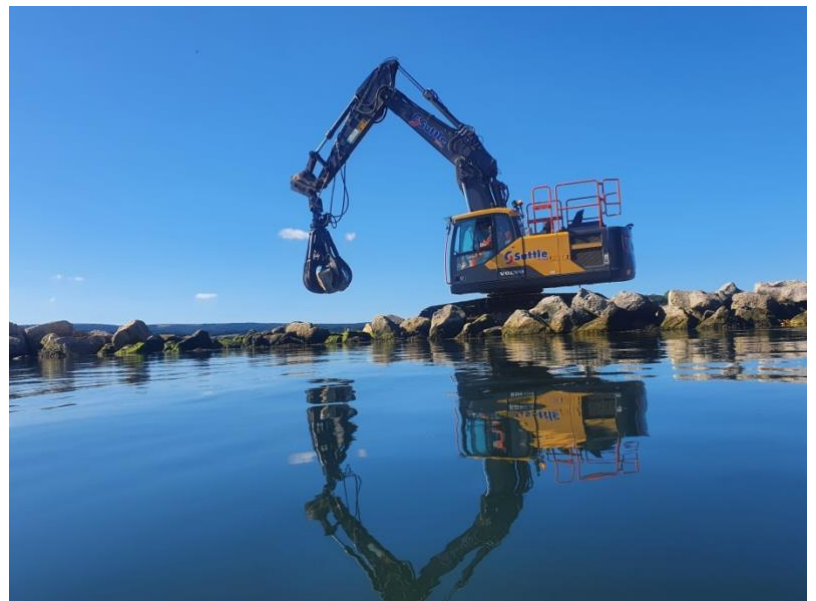
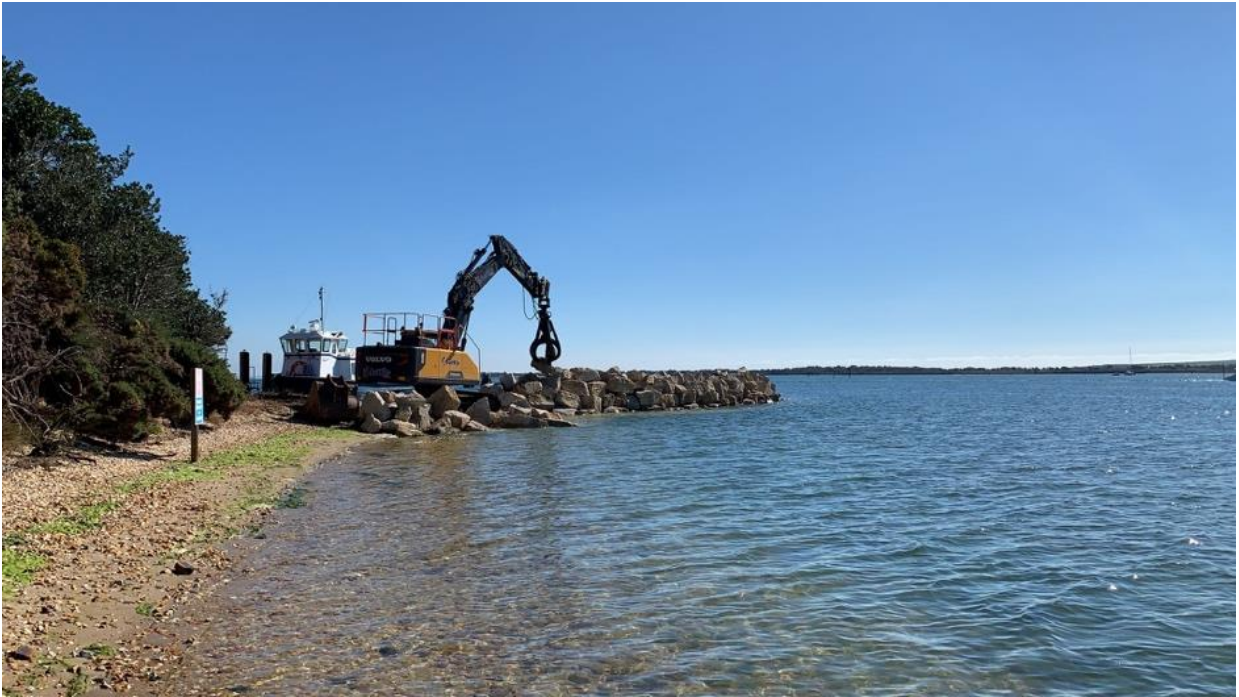
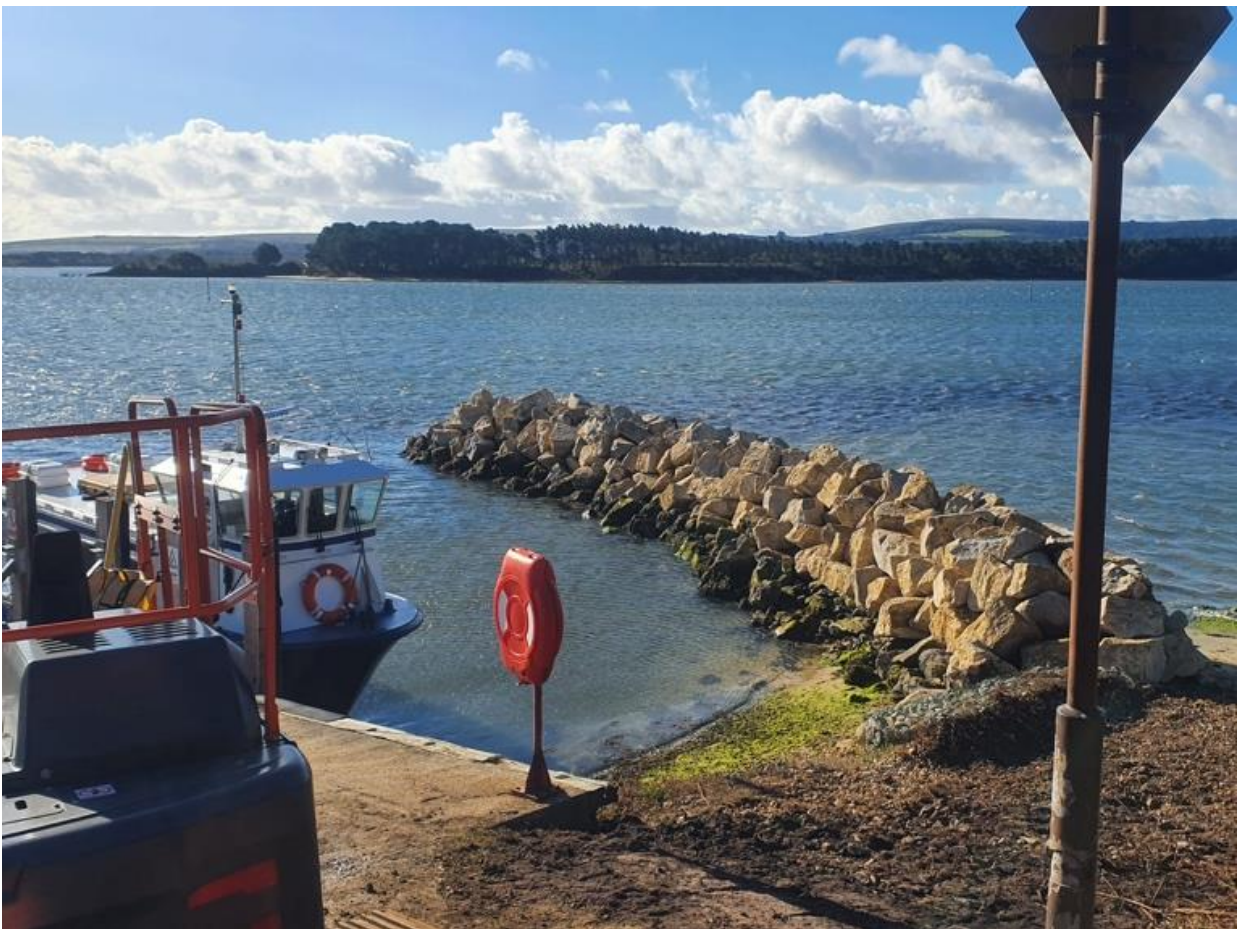
The task was to reinstate an existing 30m long rock groyne structure using over 200 tonnes of large stone boulders; ranging from ½ a tonne to 1 ½ tonnes each. The stone used was Purbeck limestone which was supplied from our sister company; Suttle Stone Quarries, located very close by in Swanage.

As the breakwater is on the island, it makes the logistics slightly more complex than usual, requiring the stone which is usually delivered by road on a lorry, to be taken, still by lorry but by putting the lorry on a barge that can carry a 100 tonne load. Several lorries made this journey over the course of the project to get all of the stone over. The barge takes the lorries from Port of Poole to Furzey and back with each leg of the journey taking 1.5 hours.

We had one of our excavators on Furzey island equipped with a multi-function hydraulic grab to receive the stones and place them to create the rock groyne. The hydraulic equipment featured biodegradable oil circuitry for further assistance. The work was completed on time, to budget, and without incident.
