LONG CURTAIN MOAT

Client: East Solent Coastal Partnership for Portsmouth City Council

Project Detail

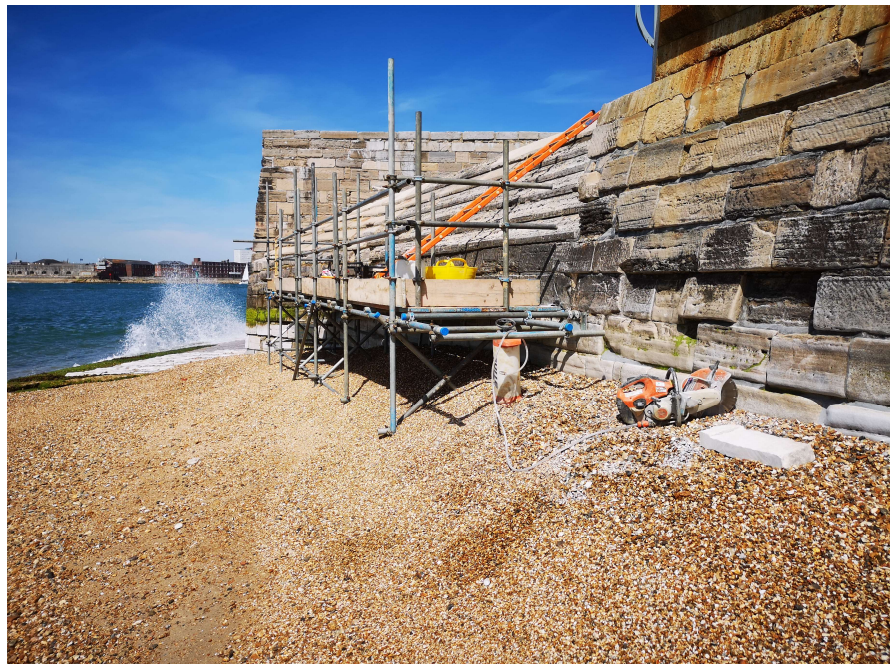
The operative on the scaffold placed the mortar and dowel bars prior to the blockwork being lifted into position by the mini-excavator, avoiding the need for manual handling.

Suttle Projects were contracted to carry out the repairs that were required to repoint the open joints and replace and secure the missing stone blockwork, in various locations, along the 35m long vertical seawall at Long Curtain Moat, in Old Portsmouth.

Prior to repointing the joints with a M60 mortar mix, each one was cleaned. This involved clearing areas of algae and, by utilising a hand-breaker, removing the loose and unsound material.

In replacing the stone blockwork, it was necessary to install a scaffold. This was set up with a double guard rail to ensure the operative's safety whilst working at height.
