PORT OF POOLE LUCAS ROAD LORRY COMPOUND AND CAR PARK

Client: Poole Harbour Commissioners

Project Detail

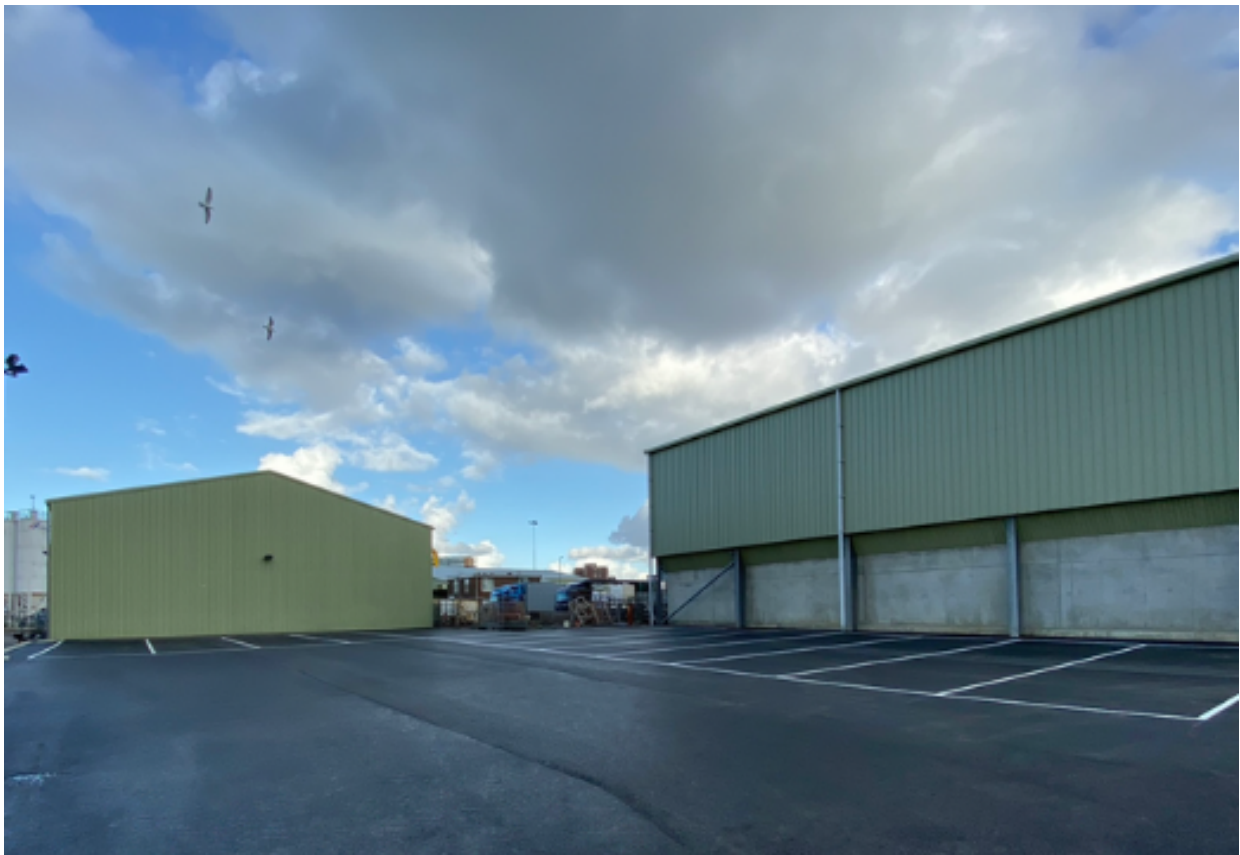
New surfacing for lorry park

Lorry Compound: Utilising our own inhouse design capability, we detailed lorry parking to accommodate 44-Tonne compliant articulated trucks, but also to allow for the use of a 77-Tonne axle cargo handling unit. The design accommodated improvements in drainage to a previously redundant area, capping, sub-base and bitumous surfacing, as well as kerbs and barriers to enclose and properly tidy the area. The design work was completed at short turnaround during a two-week period. It incorporated specialist geogrid materials to make the most efficient use of the available subgrade.

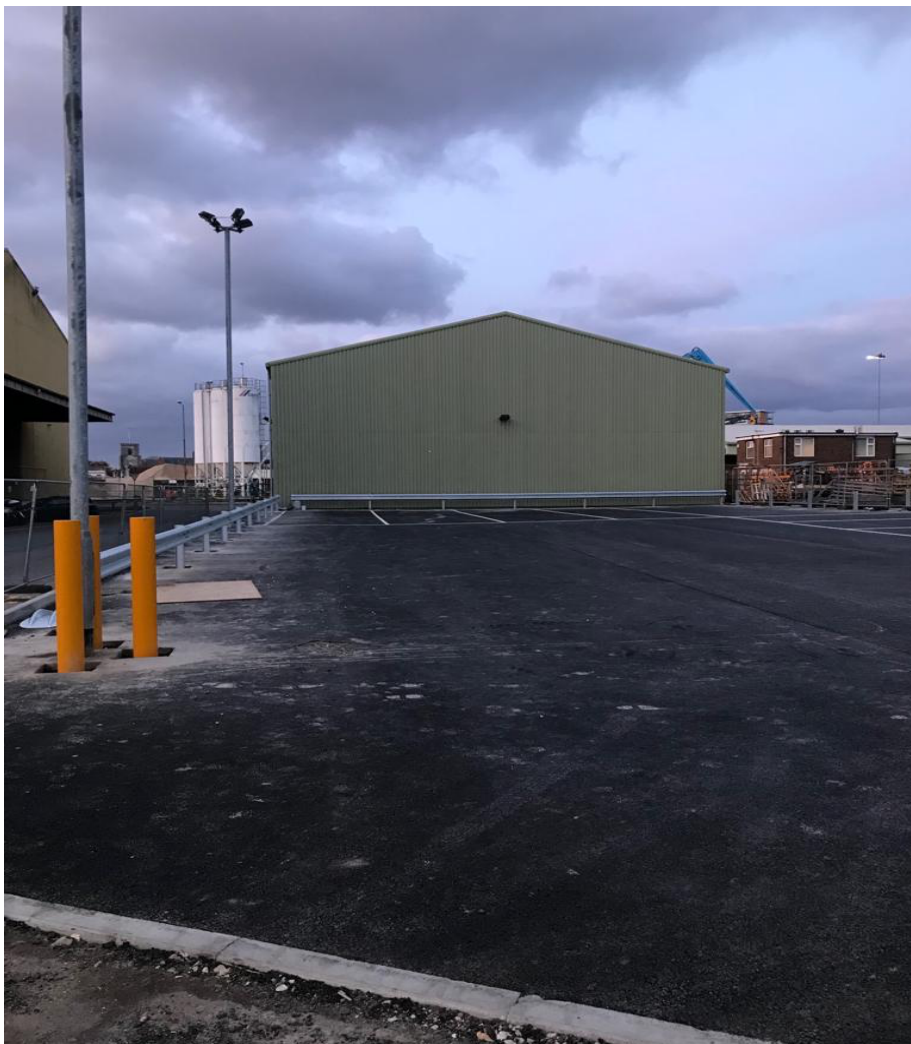
New surfacing

Car Park: Utilising Autodesk Vehicle Tracking software, our in-house design team were able to maximise the space available to create a car park for approximately 40 vehicles. First of all, we excavated the existing base and resurfaced with bitumous surfacing, then we installed Armco vehicle collision barriers, bollards and signage. Line painting, using thermoplastic road marking paint, completed the work.

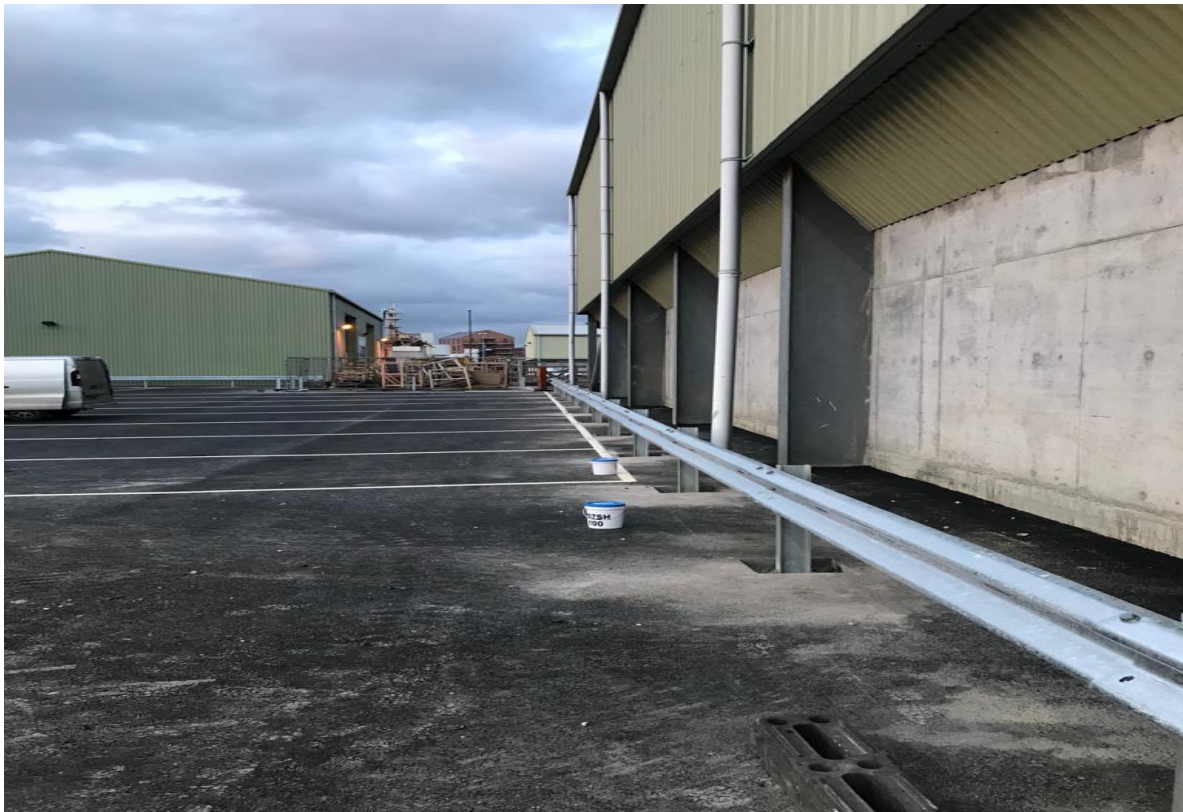
Armco barriers

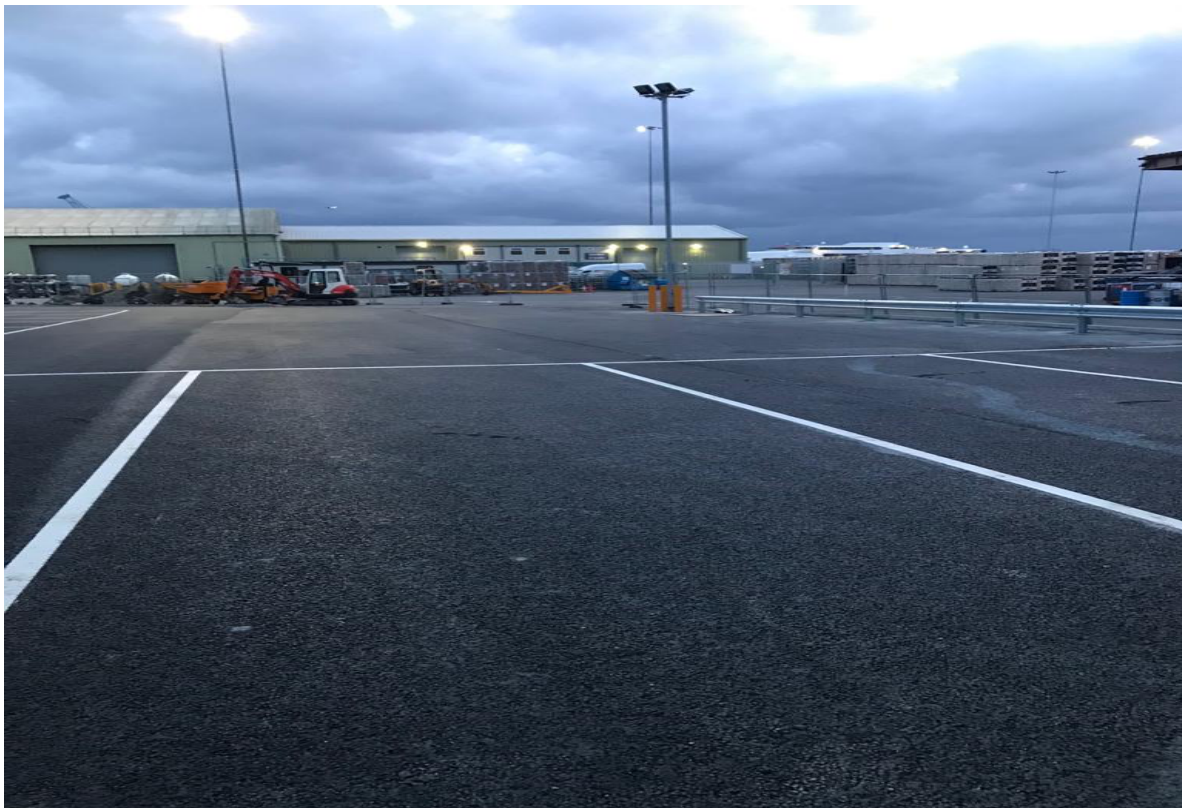
Newly surfaced lorry park

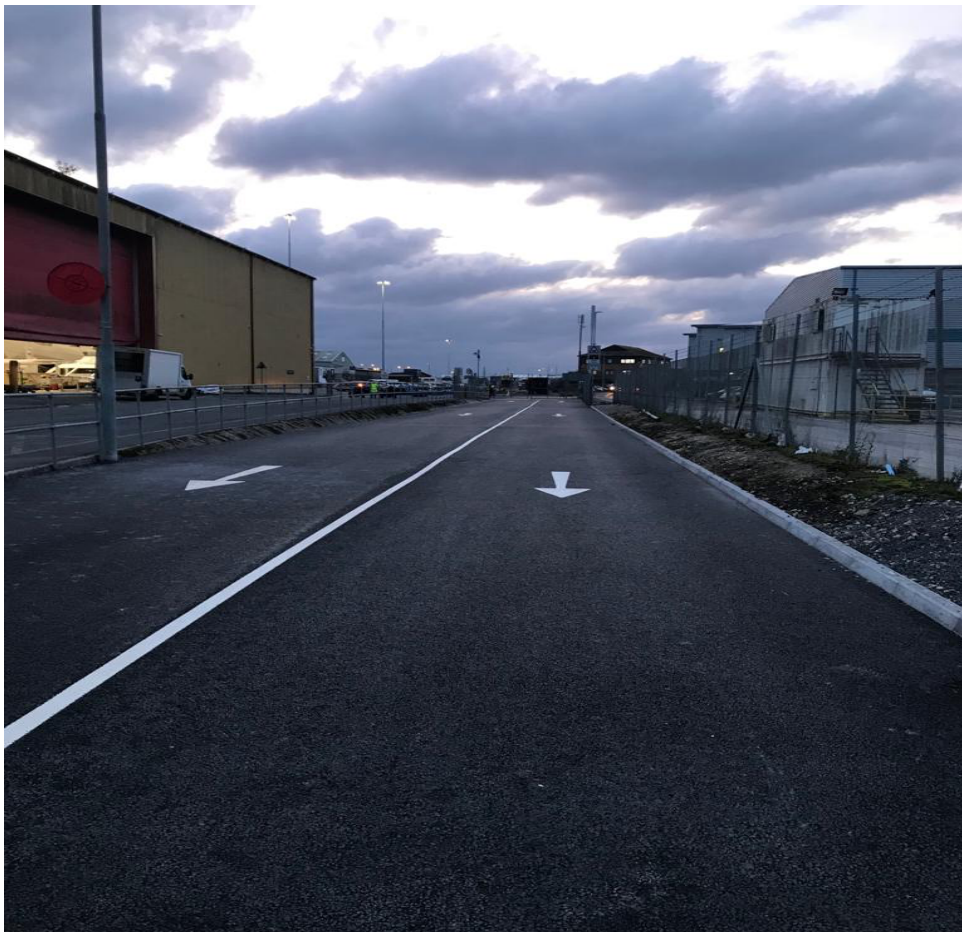
Newly surfaced lorry park
